Action C.2

2023 report of early eradication actions

RIPARIAS

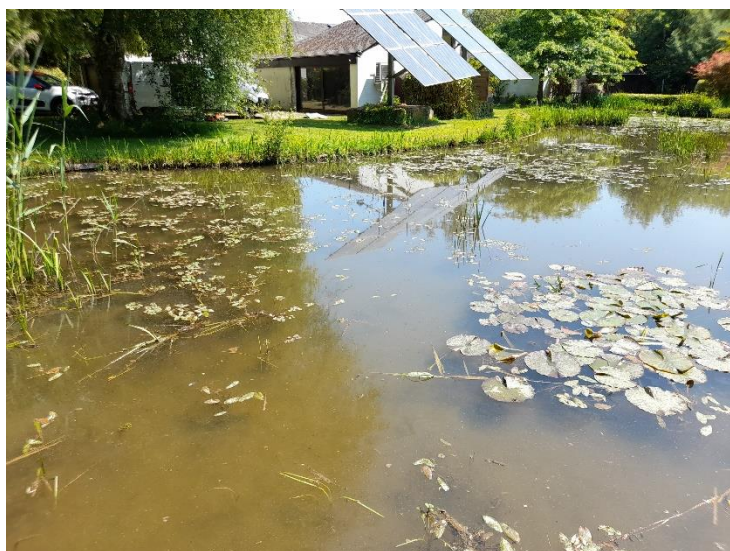
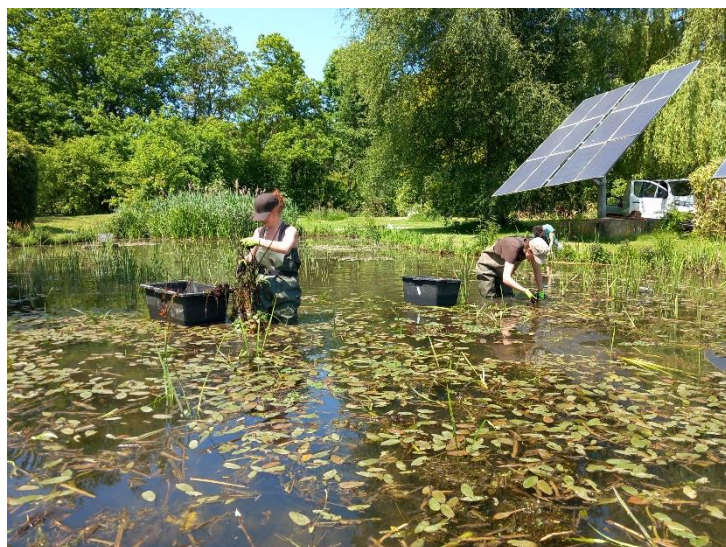
Figure 1: The pond in Ottignies before management (left) and during management of *L. peploides* (right)

The population located at Ottignies was eradicated by manual removal and aftercare. In June 2023, 1m³ of plant material was removed. There were 2 after care interventions, one in July and one in September 2023 during which respectively 0,1m³ and 0,02m³ of plant material was removed. This action was performed by CRSenne in the Summer of 2023.

The population was removed; however, it will be necessary to check in 2024 if the whole population was eradicated by this measure.

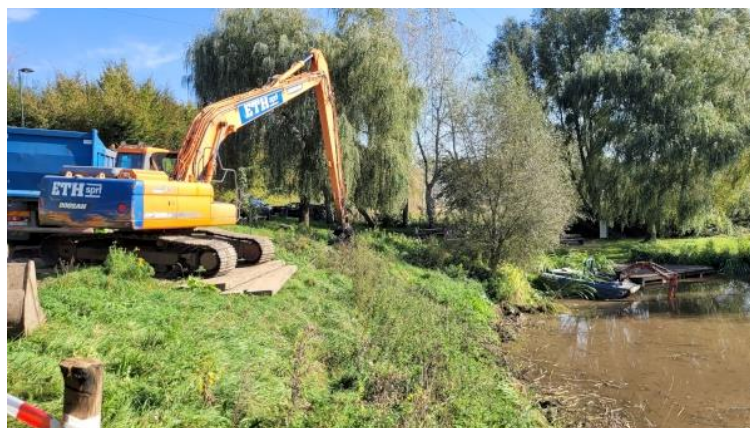
Figure 2: Machines used to perform the management of *Zizania latifolia* in a public pond in Brussels.

The population located at Anderlecht was eradicated by mechanical removal of the whole population. A large and a smaller excavator were used to dig out the rhizomes from the pond bank. About 15 truck containers of plant material and infected ground with rhizomes was removed. The presence of stones and geotextile made a second evaluation of the situation and planning of the management necessary. This eradication action was performed by BE in October-November 2023.

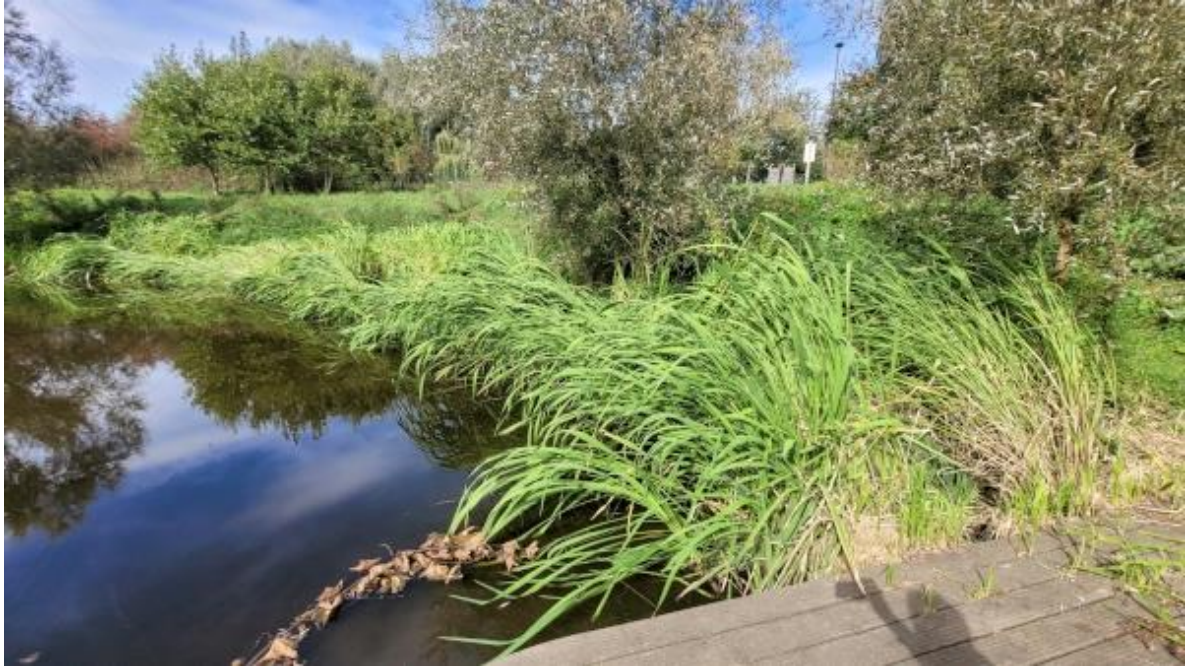
Figure 3: Part of the Zizania latifolia population (before management) in a pond in a public park managed by BE.

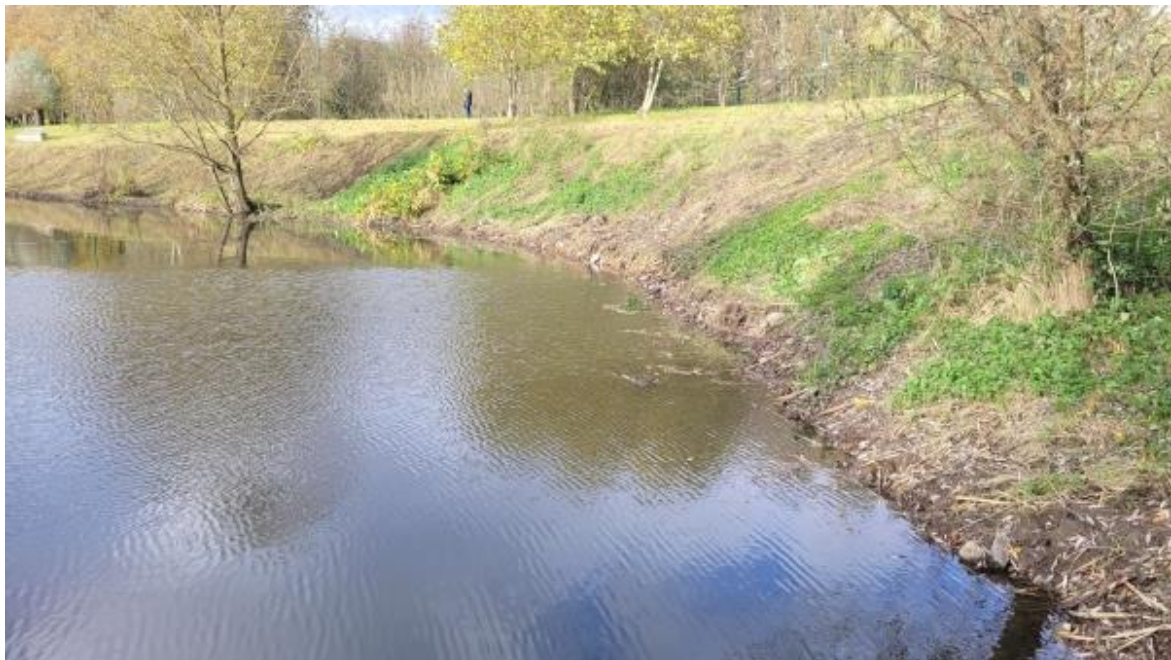
Figure 4: The same pond after management took place.

The population was removed; however, follow-up is planned in 2024 and 2025, to avoid the population to regrow from possible left-over rhizomes.

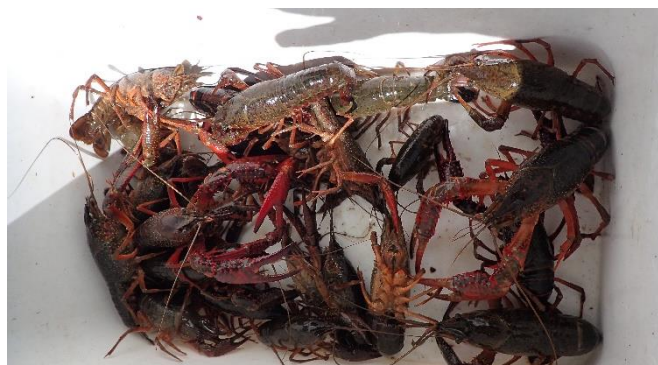
Figure 5: Some of the *Procambarus clarkii* individuals caught during the sampling & trapping phase. © Arnaud Monty (ULiège)

First, a preliminary sampling and trapping was performed from June 2019 to May 2021. The trapped crayfish were removed every 2 weeks in order to reduce their abundance and reduce the dispersion risk. During the lockdown (due to Covid 19), the capture was temporarily stopped.

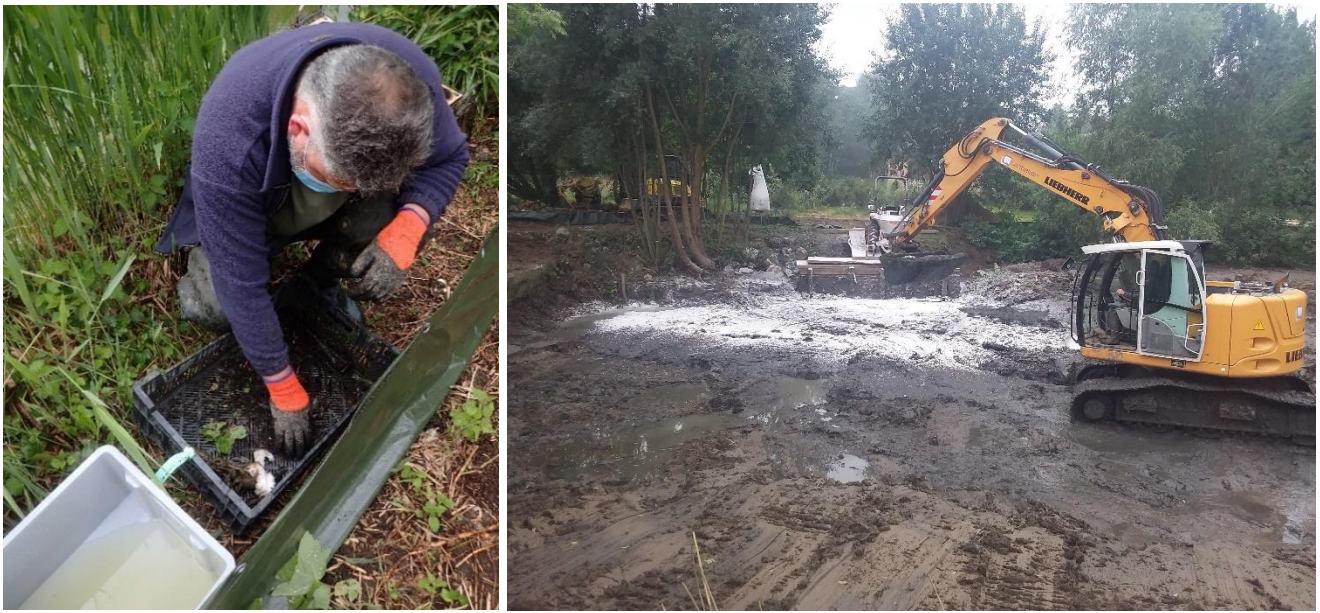
Figure 6: Removing the *Procambarus clarkii* individuals near the fence to prevent them from escaping/dispersing. (left) © Arnaud Monty (ULiège). Liming of the pond (right) © Jérémie Guyon

After the capture, the pond was fenced to prevent dispersal and a capture/mark/recapture study was performed. This resulted in an estimation of the *Procambarus clarkii* population of 750 to 900 individuals in May 2021. On the 27th of May 2021, the remaining fish were rescued by electrofishing. This was difficult due to the amount of mud.

In August 2023, another approach was used to eradicate the species. Lime was applied, sludge settling took place followed by pond restoration with containment measures to prevent escaping. To verify the effectiveness of the measures taken, baited traps were placed in the pond in November 2023, during this period (1 week) no crayfishes were caught. The management success will be verified by further trapping in 2024.

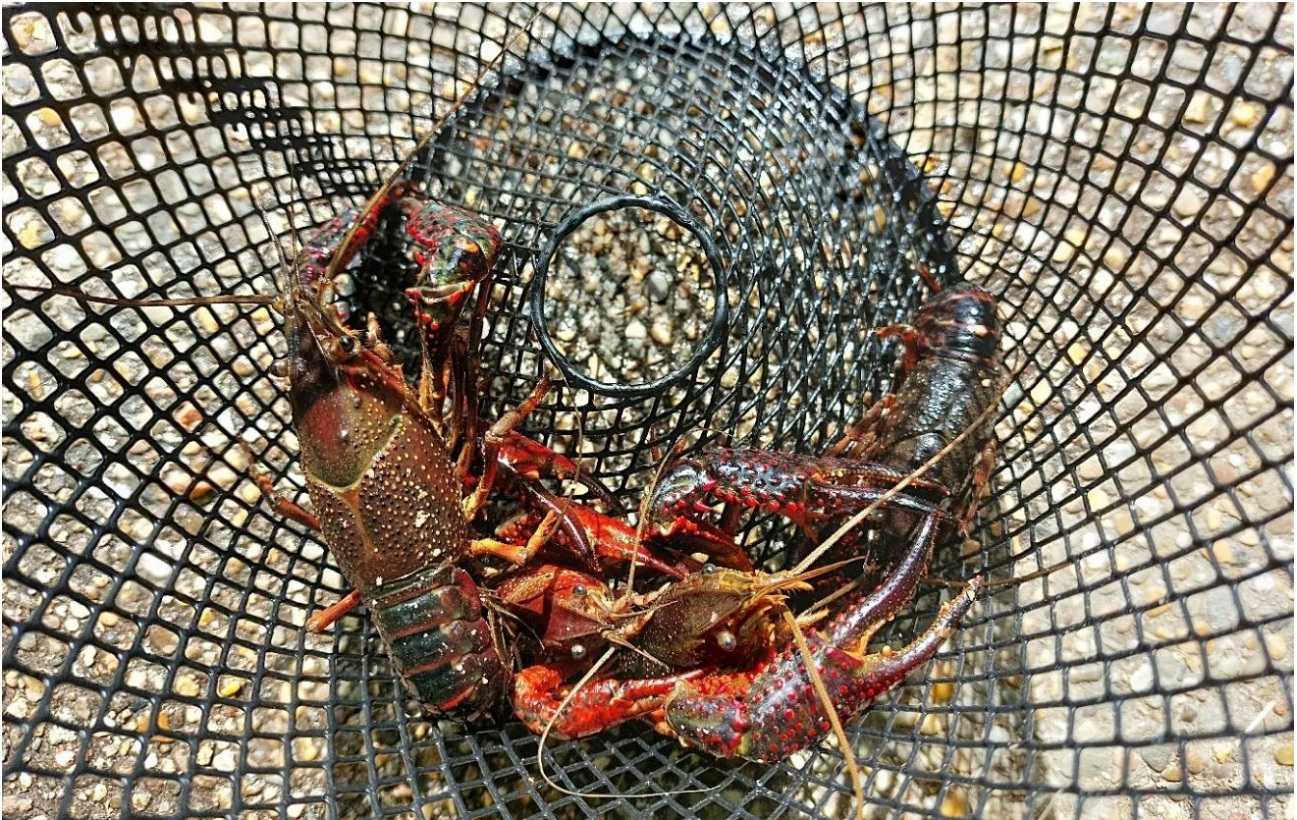
Figure 7: Procamburus clarkii individuals in a trap during the monitoring phase of the LIFE RIPARIAS project. All caught individuals were killed. An evaluation of the eradication options for these populations is still to be performed.
